Supplemental Pre-Demolition Asbestos Survey

**Tinley Park Mental Health Center
7600 183rd Street
Tinley Park, Illinois 60477**

OCTOBER 2023

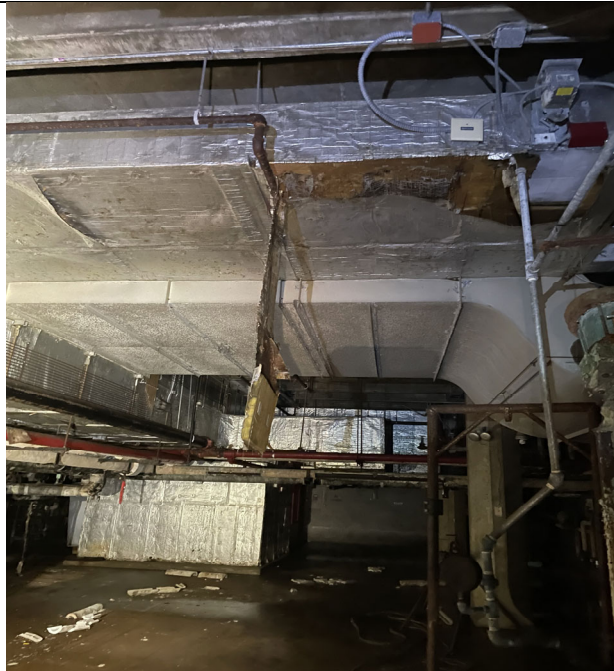
Photograph No. 1

Maple Hall
Flooded Basement and
Debris

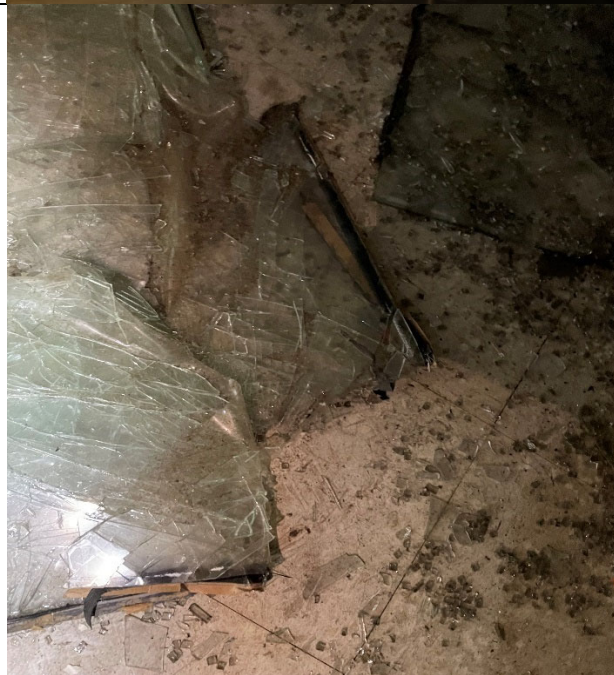
Photograph No. 2

Maple Hall
Black Sealant on Interior
Windows

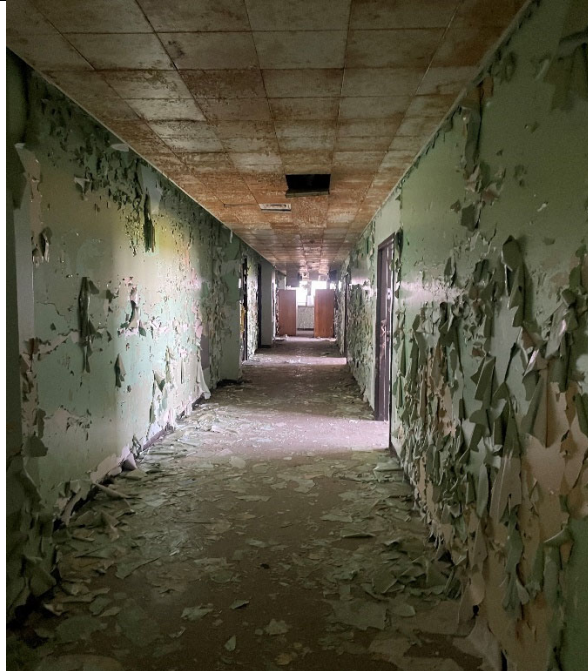
Photograph No. 3

Maple Hall
Current Conditions

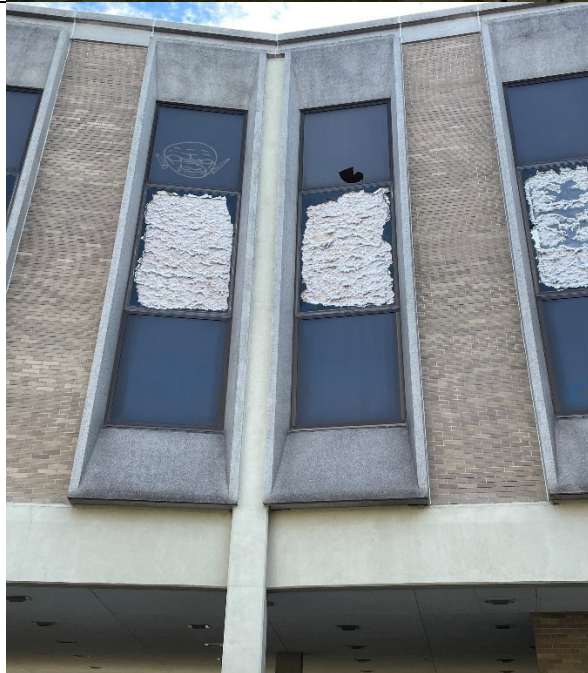
Photograph No. 4

Spruce Hall
Insulation behind False
Exterior Windows
(Center Windows)

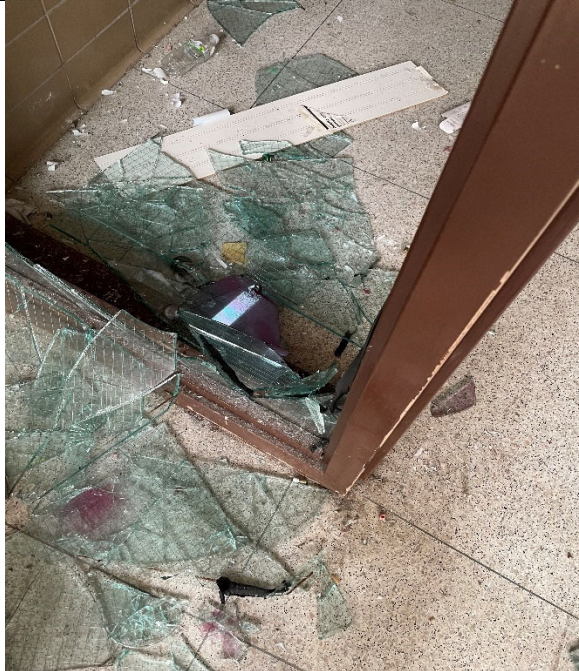
Photograph No. 5

Spruce Hall
Black Sealant on Interior
Windows

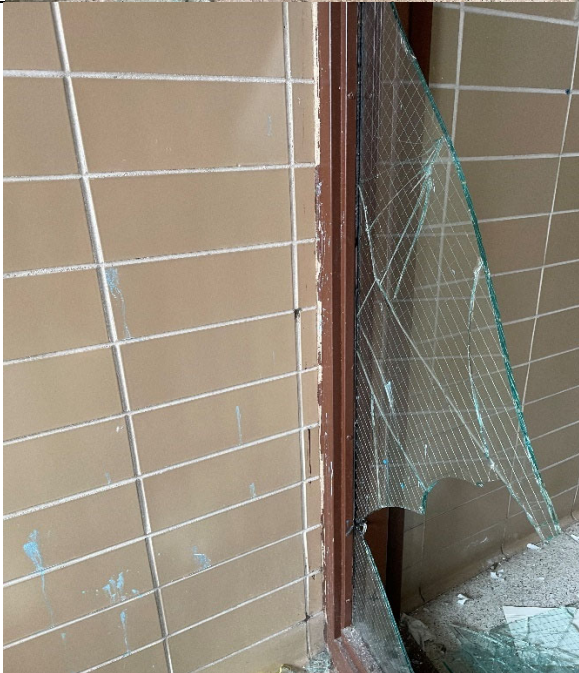
Photograph No. 6

Spruce Hall
Interior Door Caulk

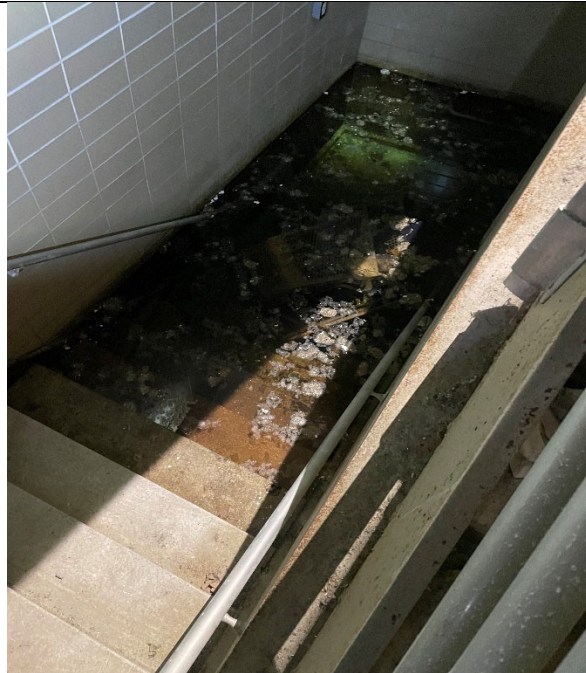
Photograph No. 7

Spruce Hall
Basement Access Flooded

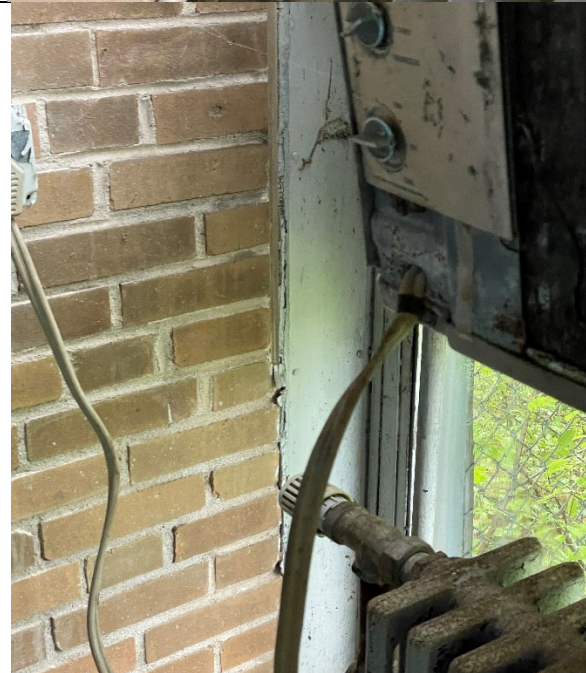
Photograph No. 8

Water Treatment Plant
Wall Seam Caulk

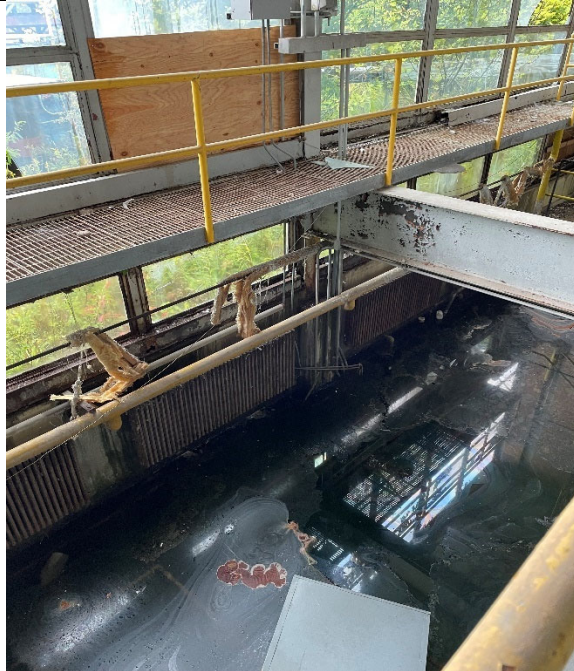
Photograph No. 9

Water Treatment Plant
Lower-Level Access Flooded

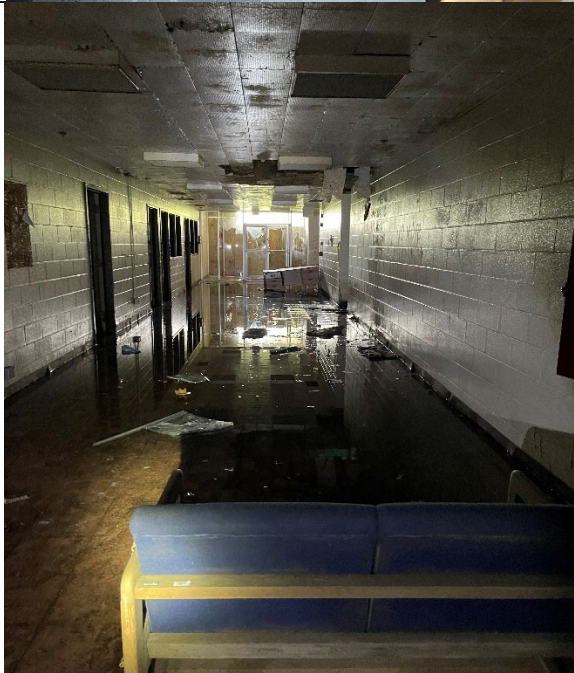
Photograph No. 10

Mimosa Hall
1st Floor Flooding

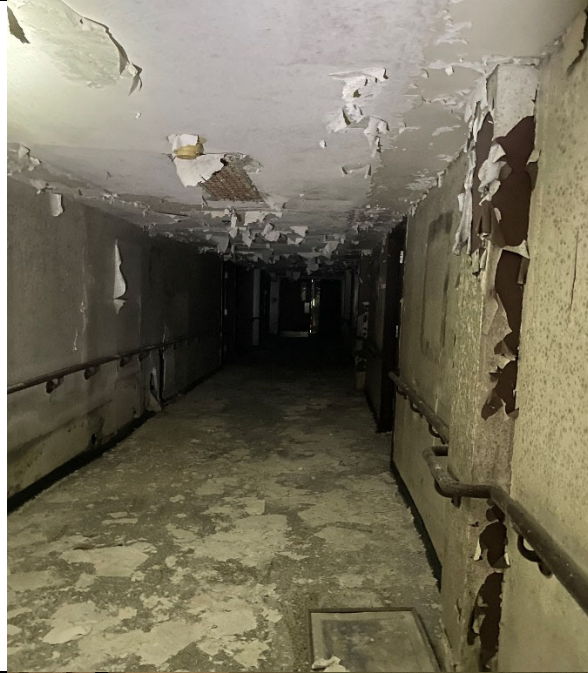
Photograph No. 11

ceilings are significantly damaged and have contaminated large portions of the building. No LBP was identified in the previous LBP inspection.

Willow Hall
ACM Acoustical Ceiling with
Significant Damage and
Debris throughout the
building.

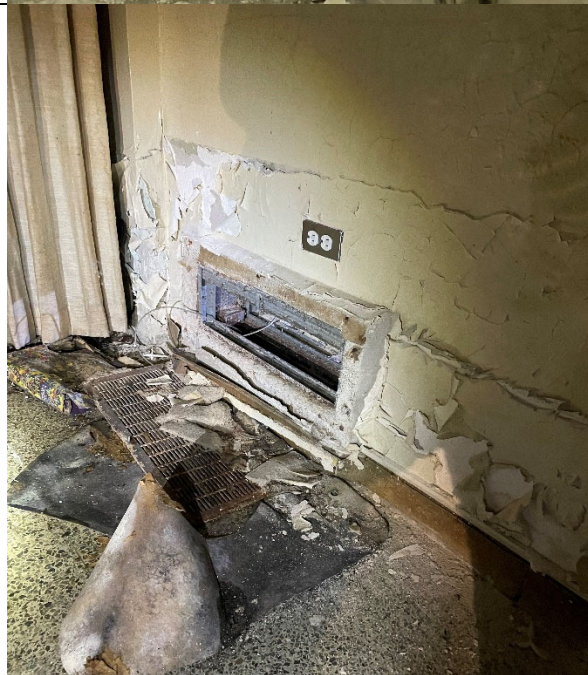
Photograph No. 12

Willow Hall
Insulation of Ventilation Ducts
(Non-ACM)

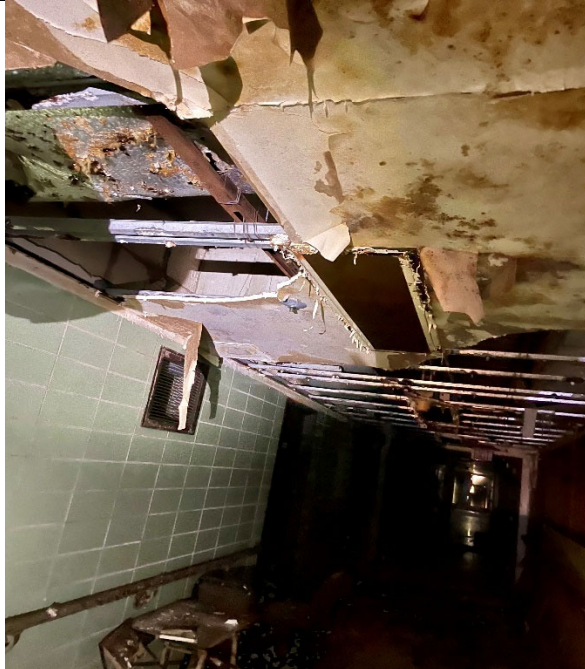
Photograph No. 13

Willow Hall
Flooded Basement

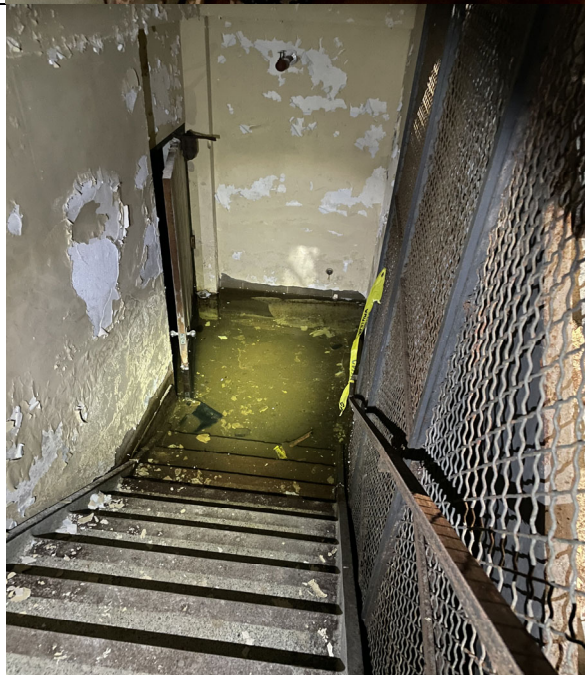
Photograph No. 14

Cedar Hall
Flooded Basement

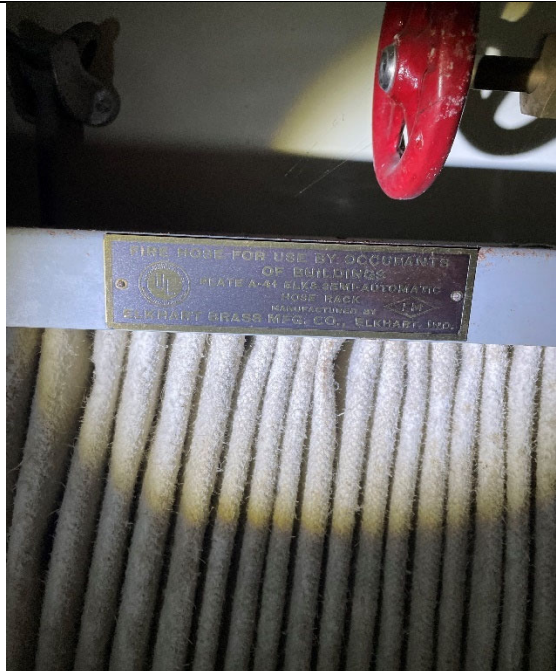
Photograph No. 15

Cedar Hall
ACM Firehouse

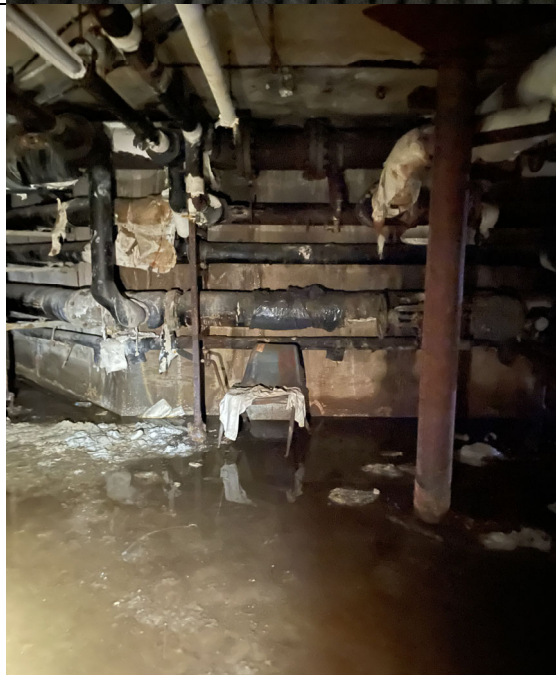
Photograph No. 16

Tunnels

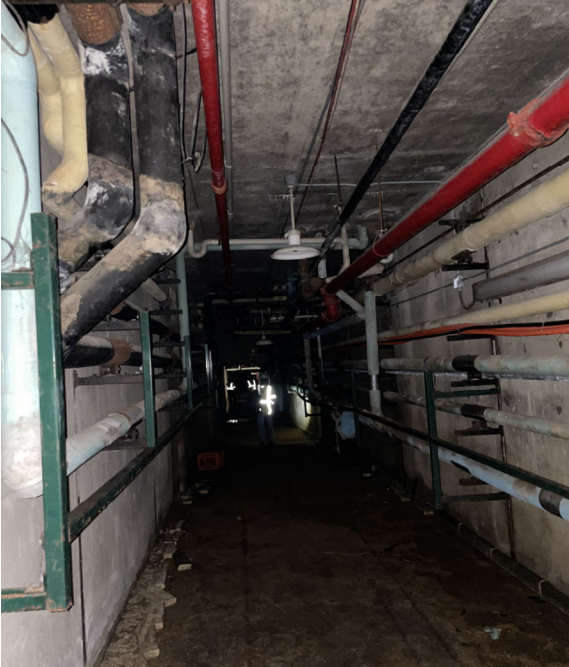
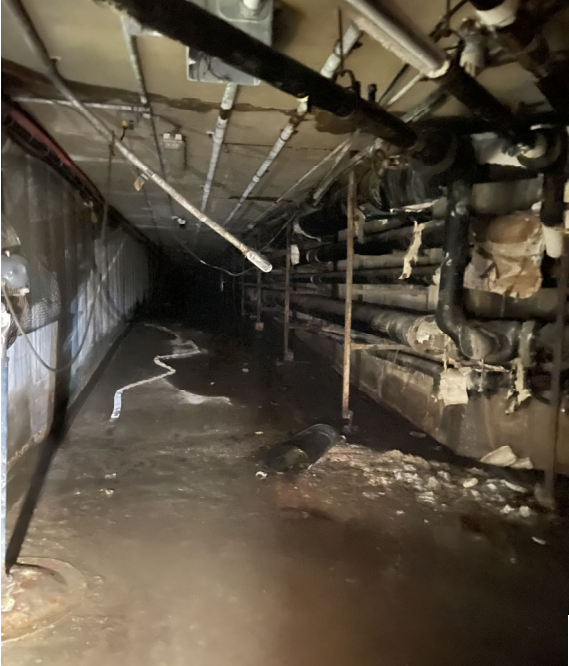
<p>Photograph No. 17</p> <p>Tunnels</p>

<p>Photograph No. 18</p> <p>Tunnels</p>

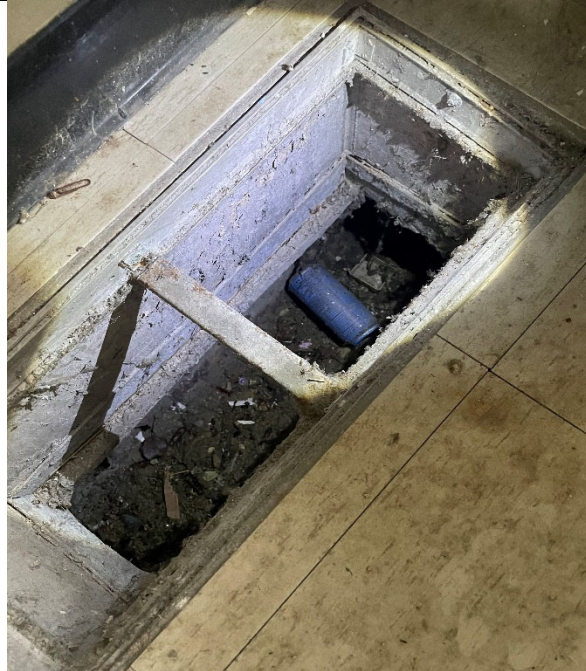
Photograph No. 19

Residential Unit 501
Typical Unit with Transite
Duct under Flooring

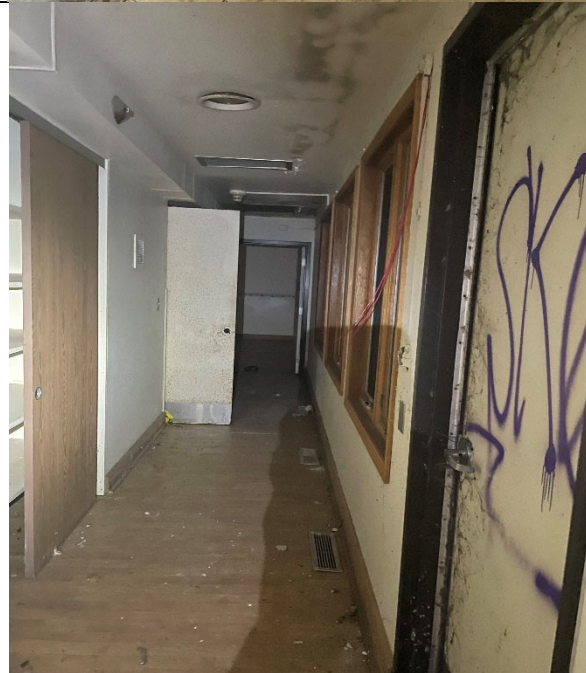
Photograph No. 20

Residential Unit 501
Laminate Flooring over ACM
Floor Tiles/ACM Mastic

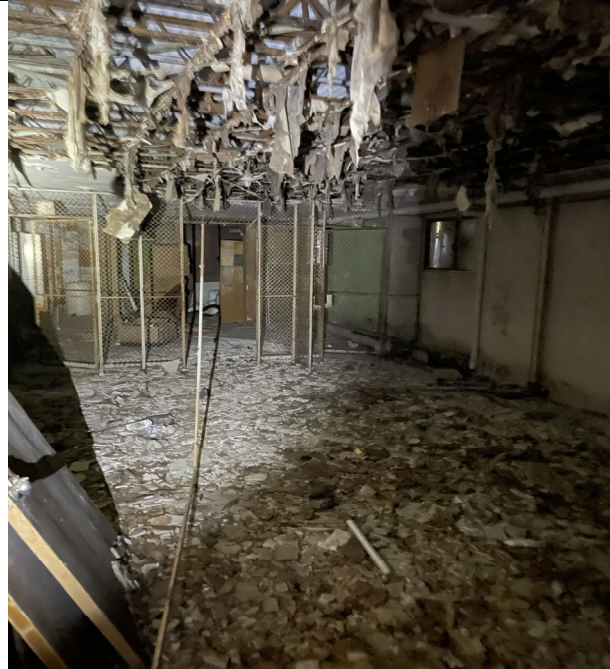
Photograph No. 21

Sycamore Hall
Conditions in Basement

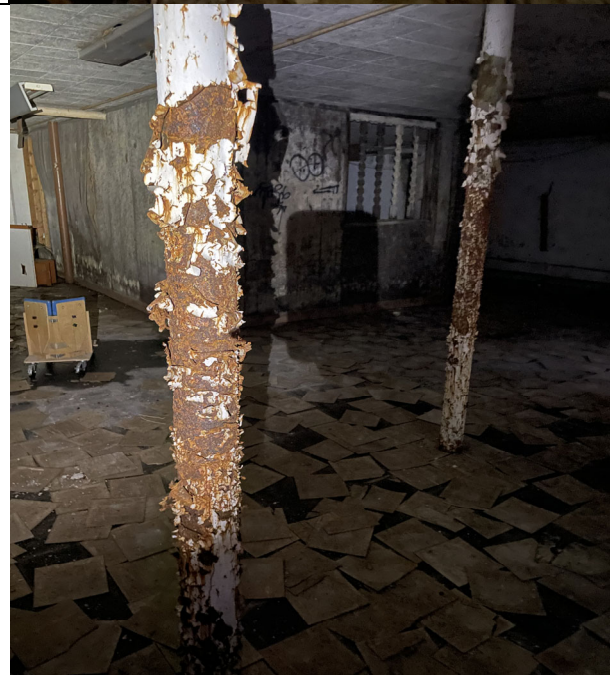
Photograph No. 22

Sycamore Hall
Conditions in Basement

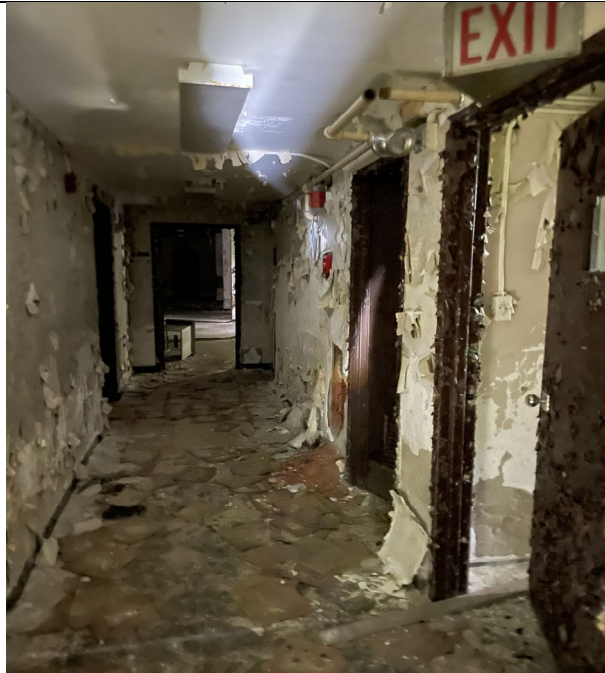
Photograph No. 23

Hickory Hall
Conditions

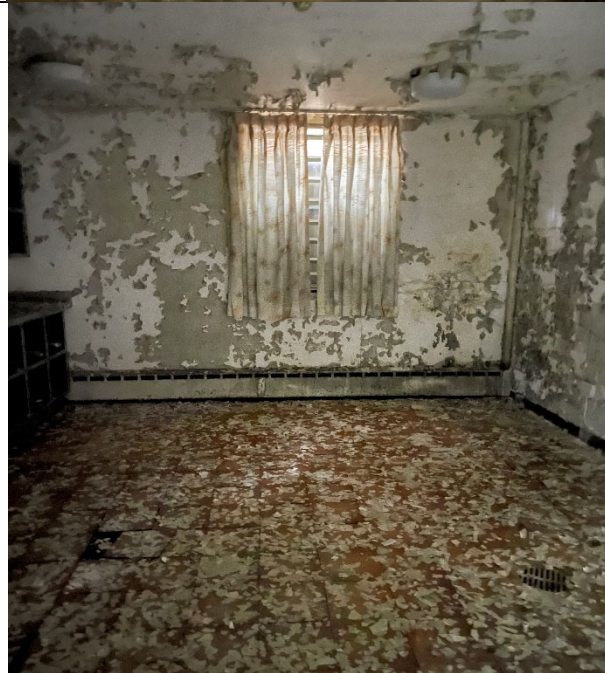
Photograph No. 24

Hickory Hall
Conditions

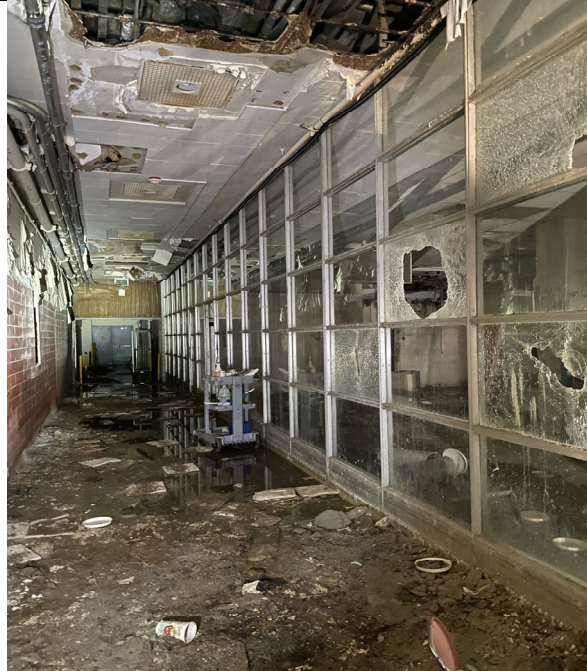
Photograph No. 25

Oak Hall
Conditions on First Floor

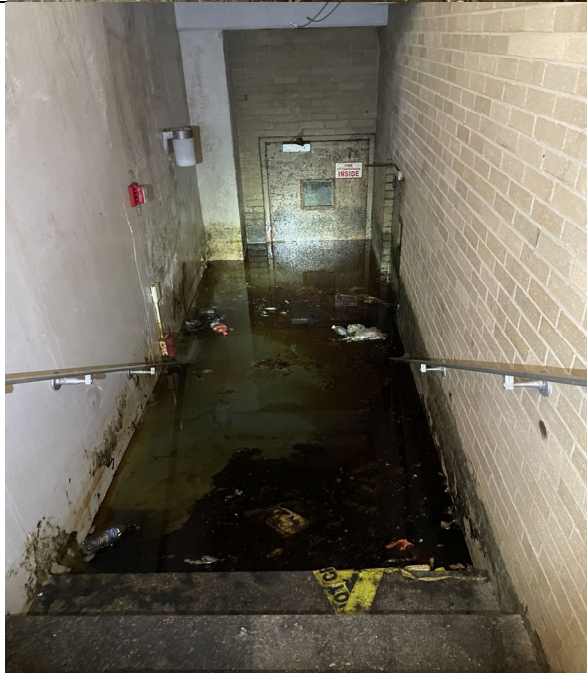
Photograph No. 26

Oak Hall
Access to Basement
