Supplemental Pre-Demolition Asbestos Survey

**Tinley Park Mental Health Center
7600 183rd Street
Tinley Park, Illinois 60477**

OCTOBER 2023

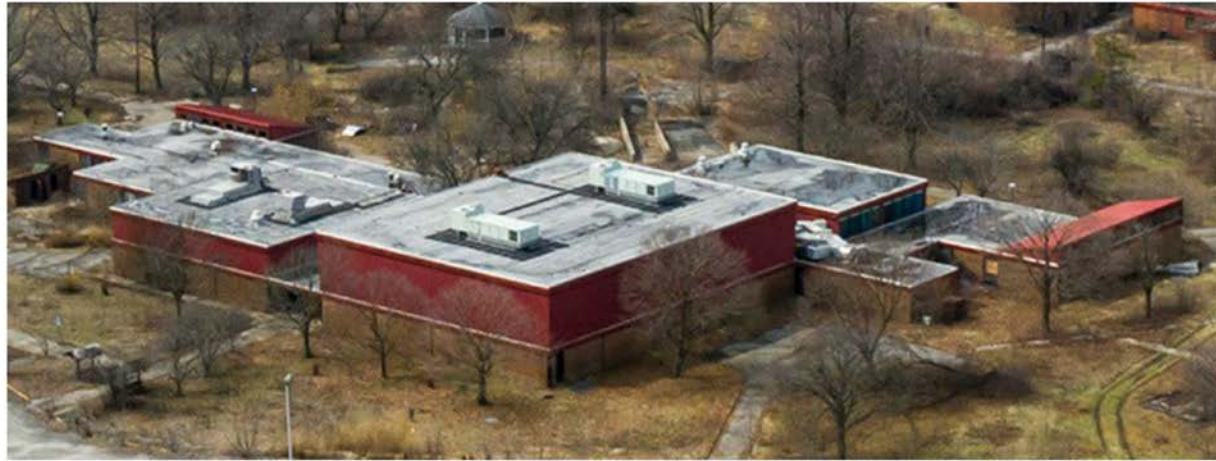
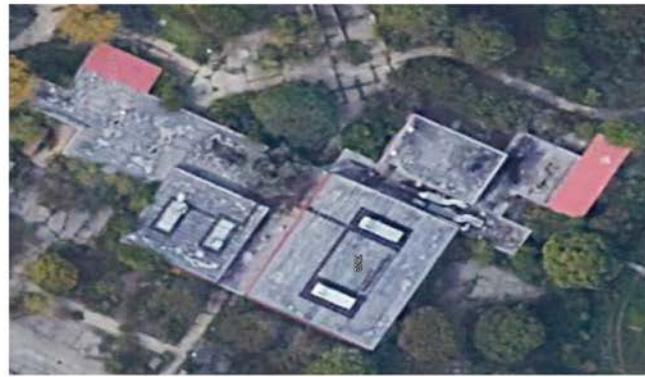
Social Hab-Pt Building CDB# B4001

Material	Quantity	Notes
1' X 1' Floor Tile and Mastic	14,023 SF	None
Fire Doors - Wood	7 each	None
Fire Damper Insulation	20 SF	None
Exhaust Backdraft Damper Insulation	50 each	None
Mastic under Wood Floor	7,960 SF	None
Ductwork Insulation on Roof	300 SF	Black tar covering parts of the fiberglass insulation on ducts
Under floor duct pipe and transite	690 LF	Material is inaccessible, estimate is based on 1994 Fox OM Plan
Transite Light Covers	60 each	None

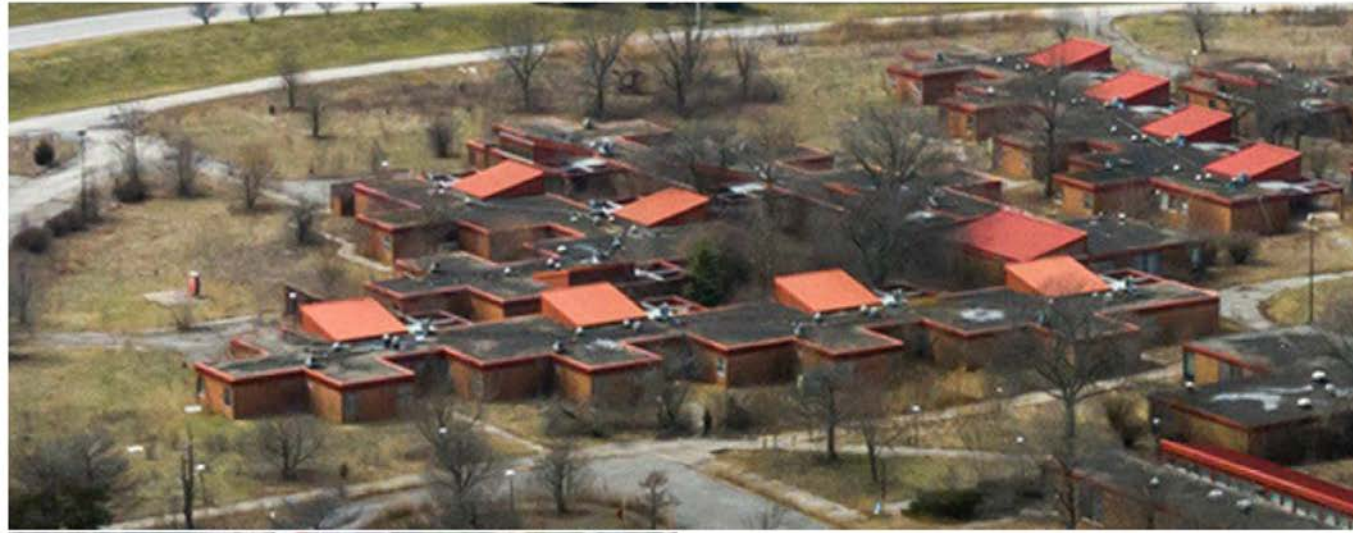
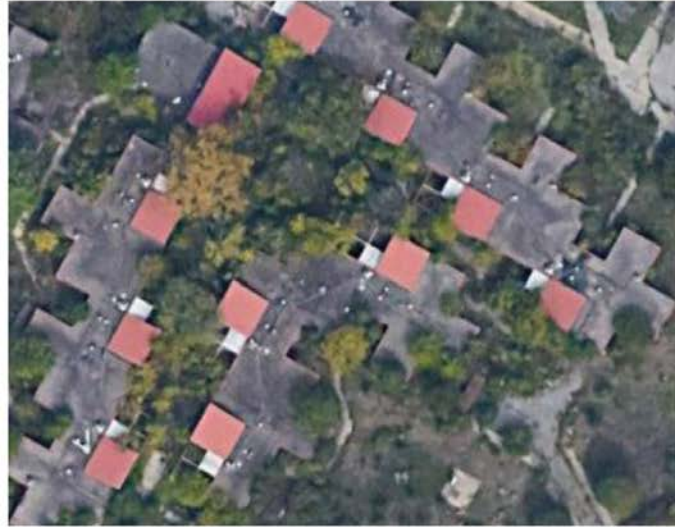
Residential Units 101-104 CDB# 4101-4104

Materials Per Unit	Quantity	Notes
1' X 1' Floor Tile and Mastic	32 SF	Abatement has removed most of this material
Fire Door - Metal	8 each	Only metal fire doors were present; no wood fire doors were identified
Insulation on Fire Damper	60 SF	None
Exhaust Backdraft Damper Insulation	60 each	None
Transite Floor Duct	1,200 LF	Material is inaccessible, estimate is based on 1994 Fox OM Plan
Light Covers	56 each	None

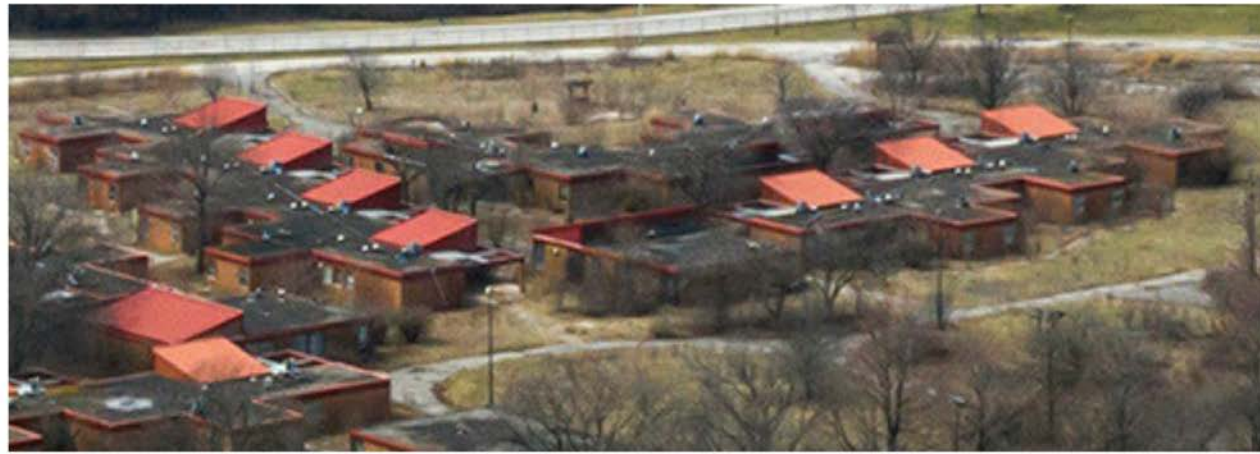
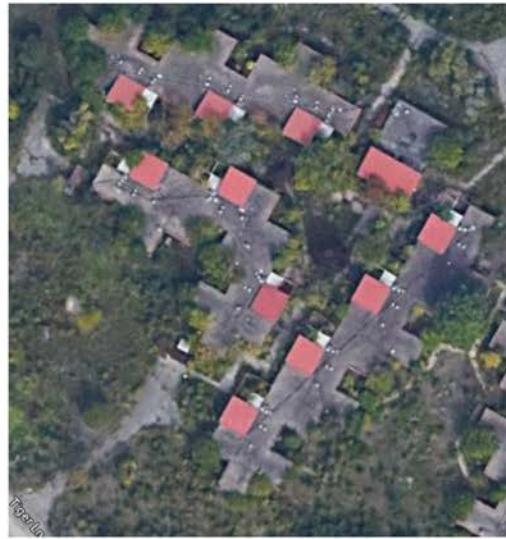
Neighborhood House 200 CDB# 4200

Material	Quantity	Notes
1' X 1' Floor Tile and Mastic	2,240 SF	None
Insulation on Fire Damper	15 SF	None
Exhaust Backdraft Damper Insulation	15 each	None
Transite Floor Duct	300 LF	Material is inaccessible, estimate is based on 1994 Fox OM Plan
Window Caulking	225 LF	None

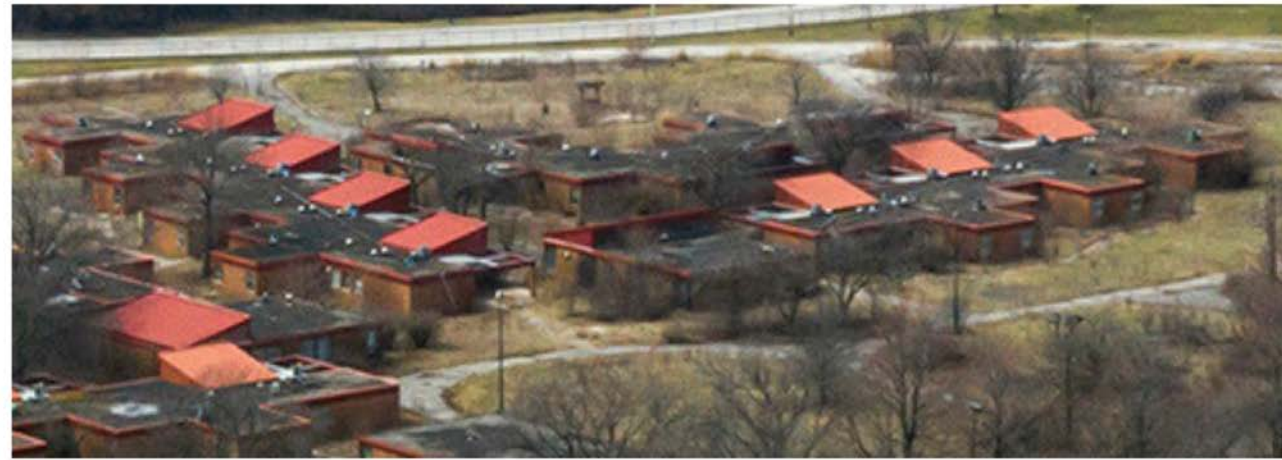
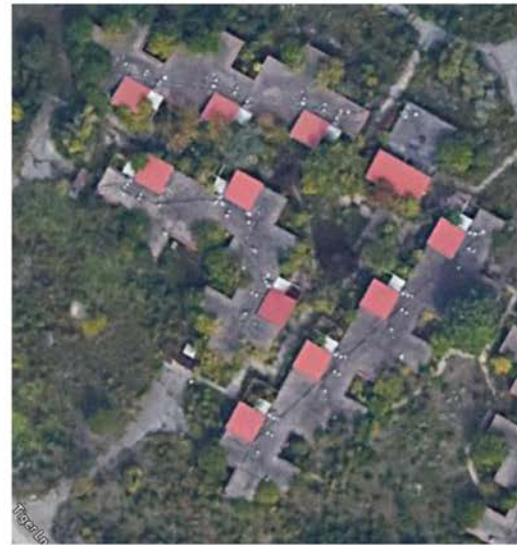
Residential Units 205-207 CDB# 4205-4207

Materials Per Unit	Quantity	Notes
1' X 1' Floor Tile and Mastic	7,740 SF	None
Fire Door - Wood	6 each	None
Fire Door - Metal	3 each	None
Insulation on Fire Damper	45 SF	None
Exhaust Backdraft Damper Insulation	45 each	None
Transite Floor Duct	900 LF	Material is inaccessible, estimate is based on 1994 Fox OM Plan
Built-up Roof and Flashing	7,350 SF	None
Light Covers	39 each	None

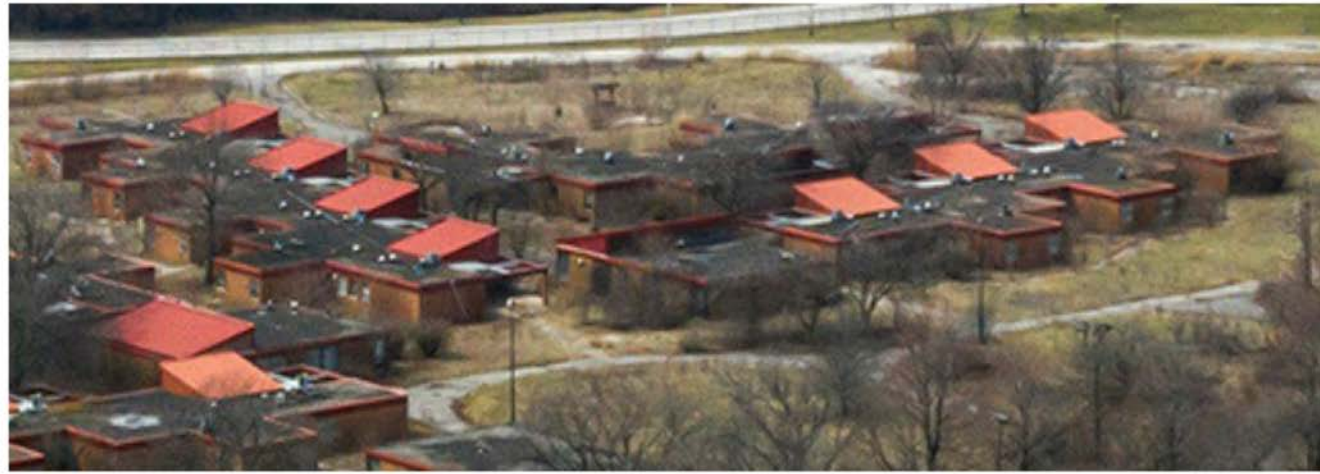
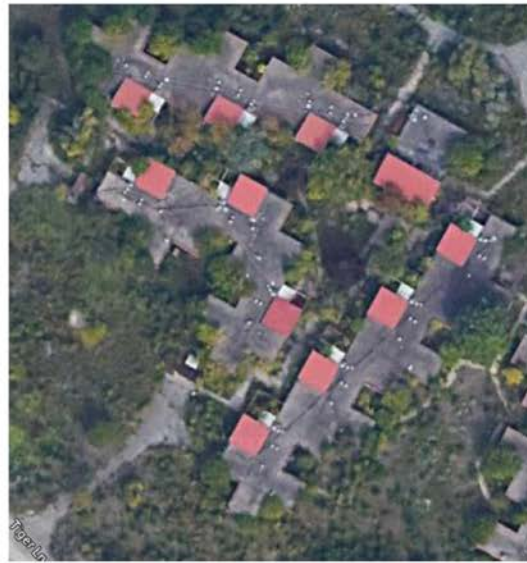
Residential Units 208-210 CDB# 4208-4210

Materials Per Unit	Quantity	Notes
1' X 1' Floor Tile and Mastic	7,740 SF	None
Fire Door - Wood	3 each	None
Fire Door - Metal	3 each	None
Insulation on Fire Damper	45 SF	None
Exhaust Backdraft Damper Insulation	45 each	None
Transite Floor Duct	900 LF	Material is inaccessible, estimate is based on 1994 Fox OM Plan
Built-up Roof and Flashing	7,350 SF	None
Light Covers	45 each	None

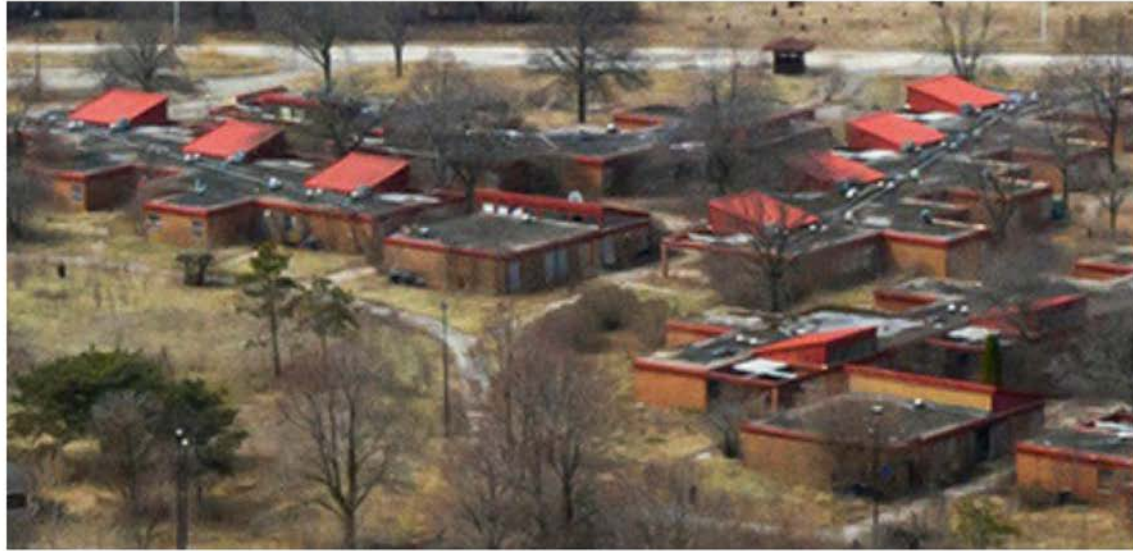
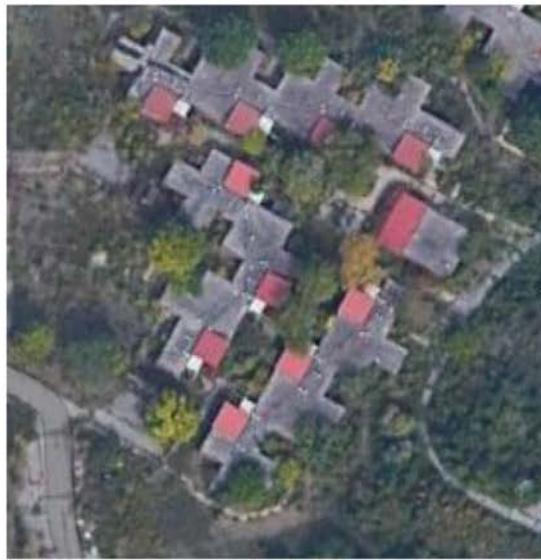
Residential Units 301-304 CDB# 4301-4304

Materials Per Unit	Quantity	Notes
1' X 1' Floor Tile and Mastic	10,160 SF	None
Fire Door - Metal	4 each	Only metal fire doors were present; no wood fire doors were identified
Insulation on Fire Damper	60 SF	None
Exhaust Backdraft Damper Insulation	60 each	None
Transite Floor Duct	1,200 LF	Material is inaccessible, estimate is based on 1994 Fox OM Plan
Light Covers	49 each	None

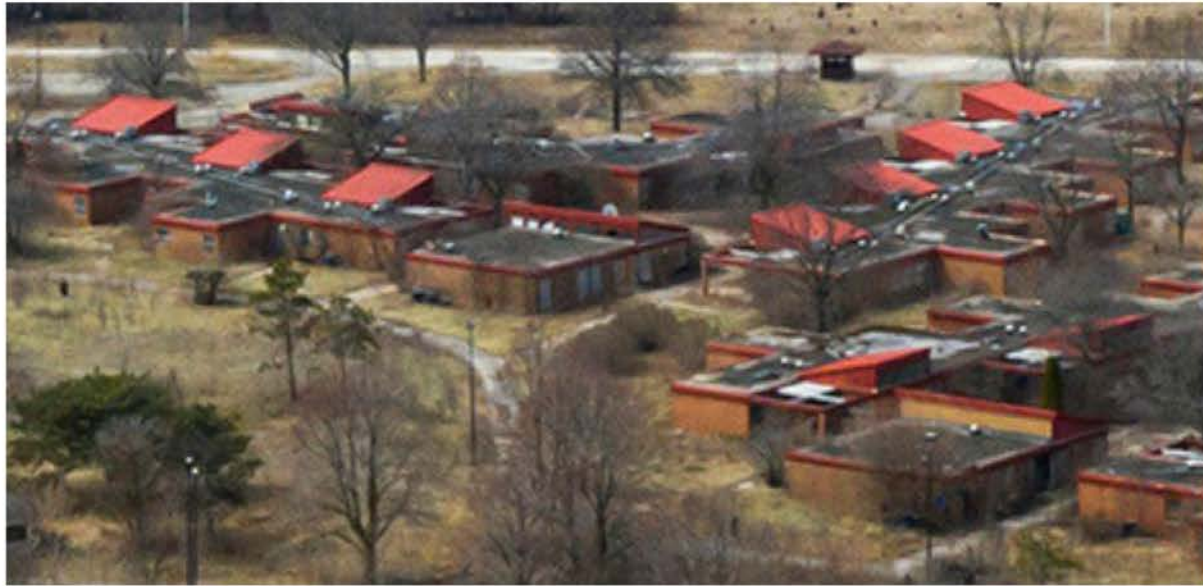
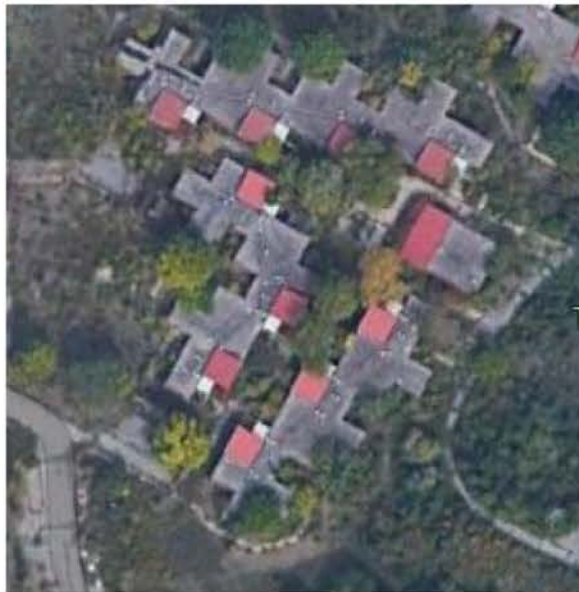
Residential Units 308-310 CDB# 4308-4310

Materials Per Unit	Quantity	Notes
1' X 1' Floor Tile and Mastic	7,740 SF	None
Fire Door - Metal	3 each	Only metal fire doors were present; no wood fire doors were identified
Insulation on Fire Damper	45 SF	None
Exhaust Backdraft Damper Insulation	45 each	None
Transite Floor Duct	900 LF	Material is inaccessible, estimate is based on 1994 Fox OM Plan
Light Covers	39 each	None

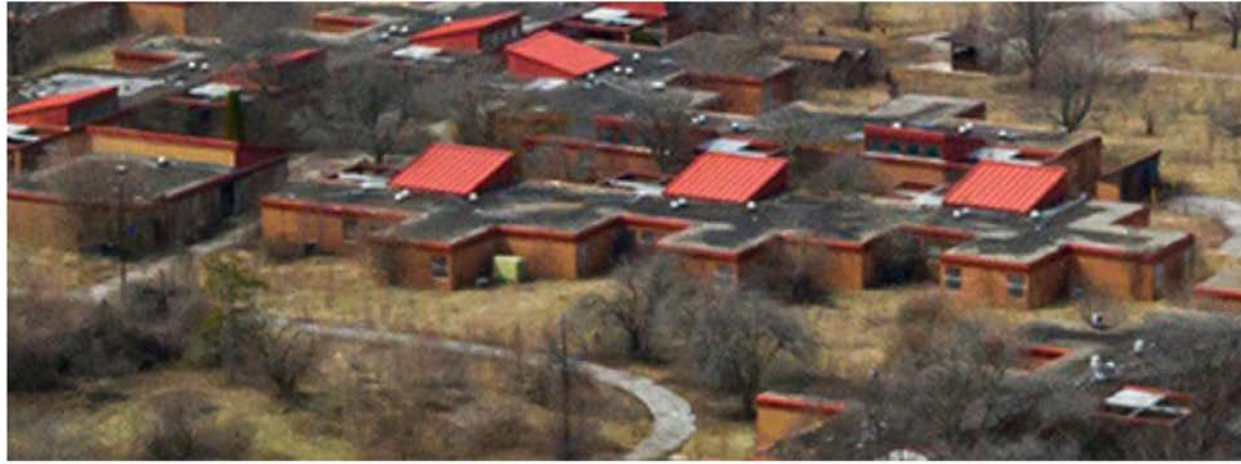
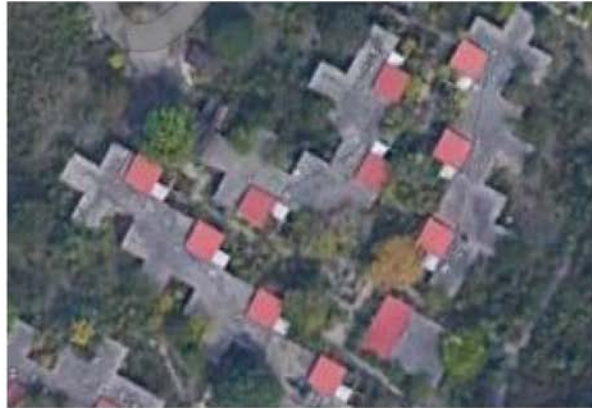
Residential Units 401-404 CDB# 4401-4404

Materials Per Unit	Quantity	Notes
1' X 1' Floor Tile and Mastic	8,700 SF	None
Fire Door - Wood	8 each	None
Fire Door - Metal	4 each	None
Insulation on Fire Damper	60 SF	None
Exhaust Backdraft Damper Insulation	60 each	None
Transite Floor Duct	1,200 LF	Material is inaccessible, estimate is based on 1994 Fox OM Plan
Built-up Roof and Flashing	9,800 SF	None
Light Covers	60 each	None

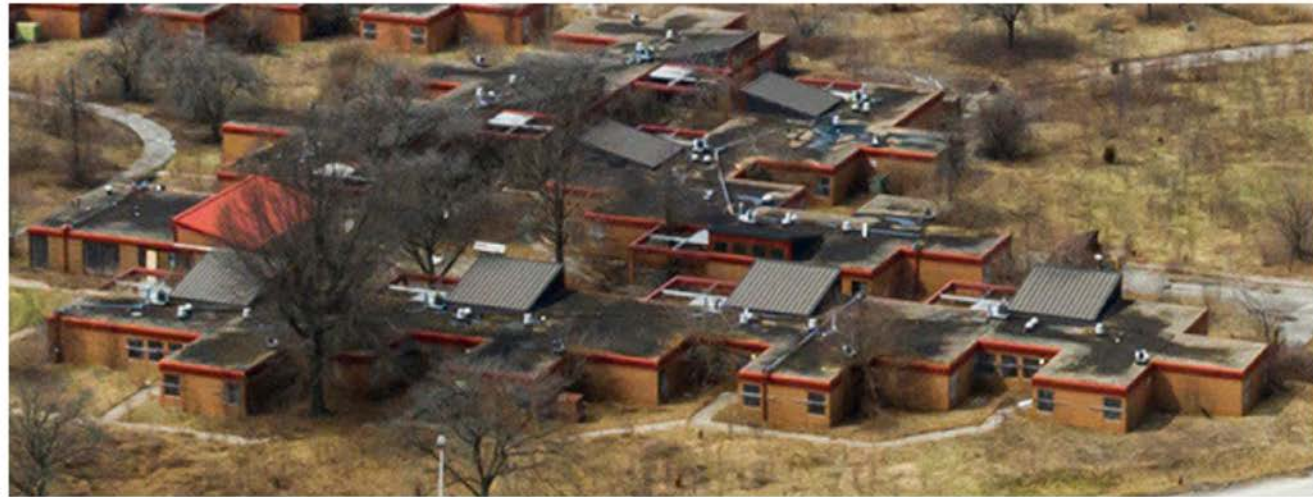
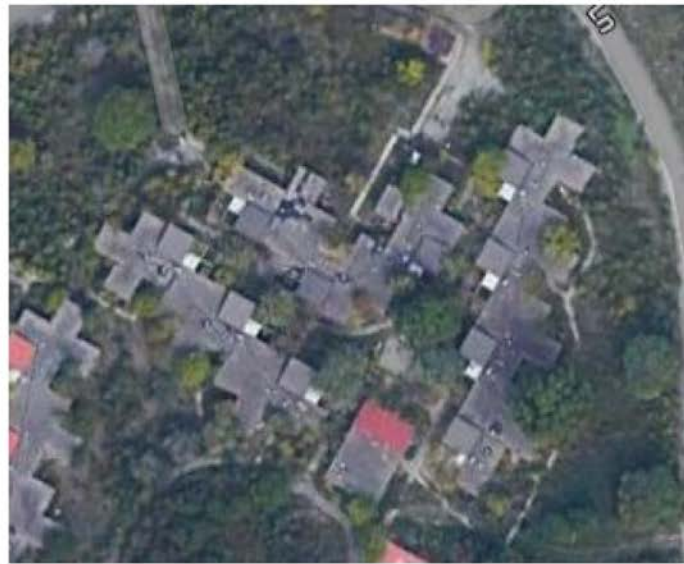
Neighborhood House 500 CDB# 4500

Material	Quantity	Notes
1' X 1' Floor Tile and Mastic	2,285 SF	None
Insulation on Fire Damper	15 SF	None
Exhaust Backdraft Damper Insulation	15 each	None
Transite Floor Duct	300 LF	Material is inaccessible, estimate is based on 1994 Fox OM Plan

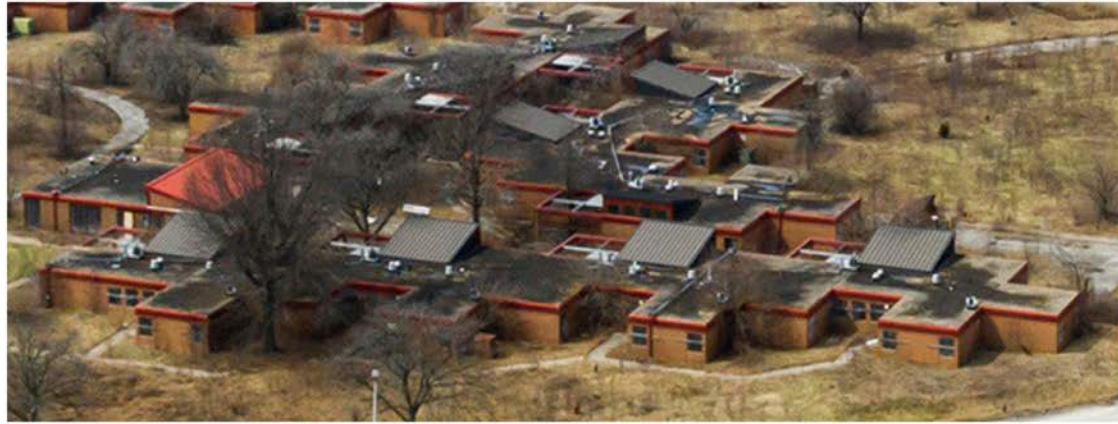
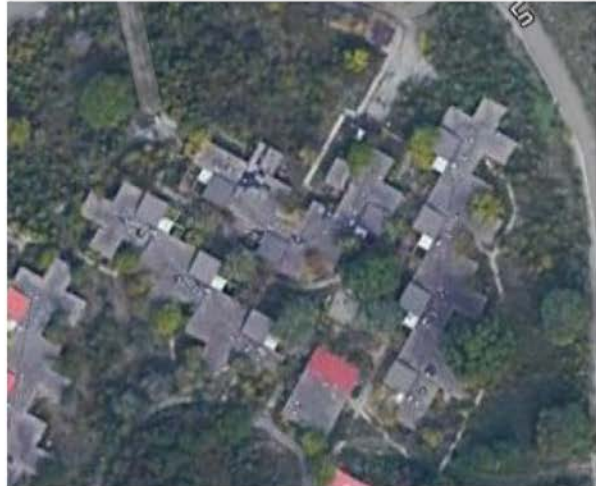
Residential Units 501-504 CDB# 4501-4504

Materials Per Unit	Quantity	Notes
1' X 1' Floor Tile and Mastic	9,880 SF	Floor tile has been removed; only mastic remains
Fire Door - Wood	4 each	None
Fire Door - Metal	8 each	None
Insulation on Fire Damper	60 SF	None
Exhaust Backdraft Damper Insulation	60 each	None
Transite Floor Duct	1,200 LF	Material is inaccessible, estimate is based on 1994 Fox OM Plan
Built-up Roofing	9,800 SF	None
Light Covers	60 each	None

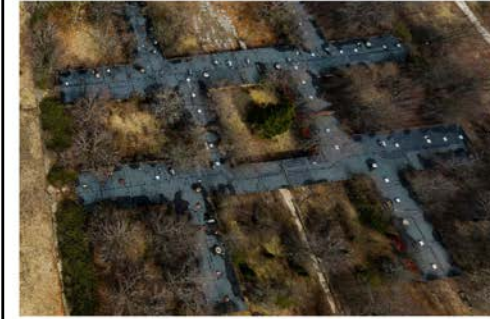
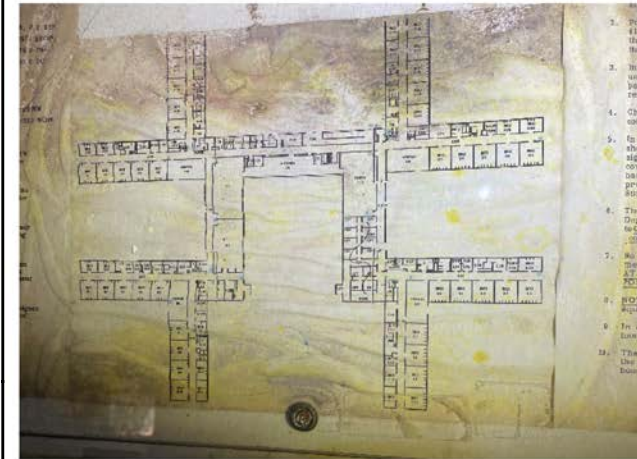
Willow Hall CDB# BB019

Material	Quantity	Notes
TSI*	11,600 LF	None
Sprayed-on Speckled Plaster Ceiling	31,090 SF	Significant Damage Contaminating Large Portions of the Building
Insulation on Ventilation Duct	10,000 SF	None
Flue Insulation Mag Block	300 SF	None
ACM Firehose	4 each	None
Exterior Transite Panels	13,900 SF	None
Electrical Wiring	NQ	Not quantified
Electrical Panel Components	NQ	Not quantified
Stockpiled Insulation Mag Block	NA	Could not identify/verify - inaccessible crawl space

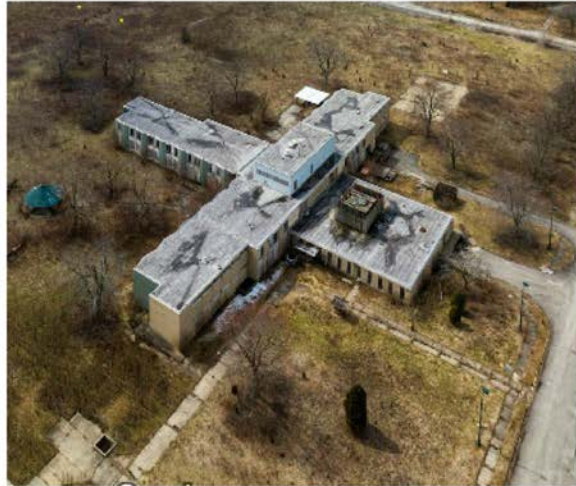
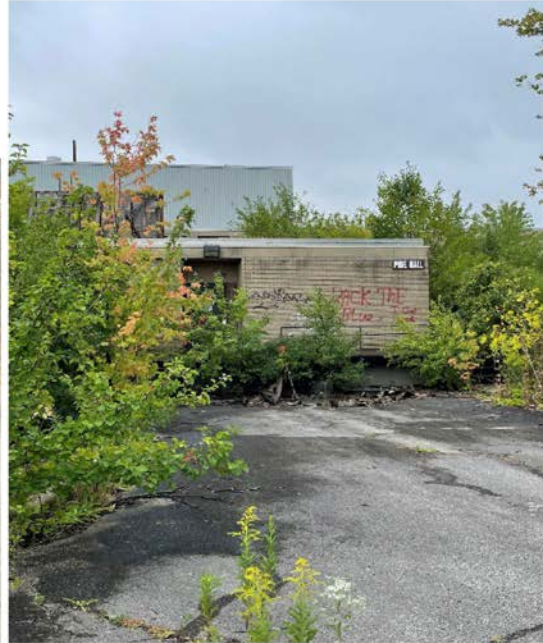
Pine Hall CDB# B4031

Material	Quantity	Notes
TSI*	6,500LF	None
Flash Tank Insulation	150 SF	None
Insulation on Ventilation Duct	700 SF	None
Black Mastic with Flooring	38,054 SF	Multiple flooring has been removed and replaced, but asbestos containing black mastic is still present
Electrical Wiring	NQ	Not quantified
Electrical Panel Components	NQ	Not quantified
Fire Door	22 each	None

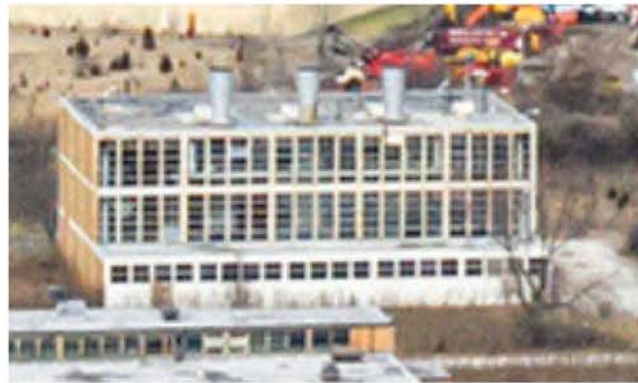
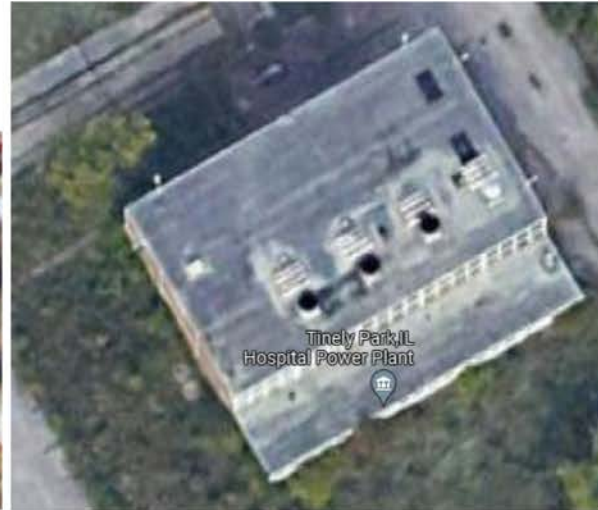
Power Plant #8 Plant CDB# BB008

Material	Quantity	Notes
TSI*	4,200 LF	Throughout building - various pipe runs and joints (all non fiberglass)
Boiler Insulation	9,200 SF	Boiler #1 and #2
Boiler Components	NQ	Demolition and removal of all Boilers
Flue Insulation	590 SF	None
Flue Insulation #2	1,250 SF	None
Cementitious Fitting on Electrical Conduit	50 LF	None
Cementitious Insulation on Holding Tank	170 SF	None
Cementitious Insulation on Hot Water Tank #1 and #2	960 SF	None
Cementitious Insulation on Conditioning Tank #1 and #1	480 SF	One tank is no longer wrapped and the other is wrapped in dark blue insulation which appears to be fiberglass
Cementitious Insulation on Oil Heating Converter	100 SF	None
Feed Water Tank (TSI)	450 SF	None
Exhaust Backdraft Damper Insulation	15 each	None
Electrical Wiring	NQ	Not quantified
Electrical Panel Components	NQ	Not quantified
ACM Firehose	2 each	None
Boiler Gaskets	15 each	None
Asbestos Stockpile	10 SF	None

Lead-Based Paint	1,500 SF**	Gray on boilers and white exterior walls

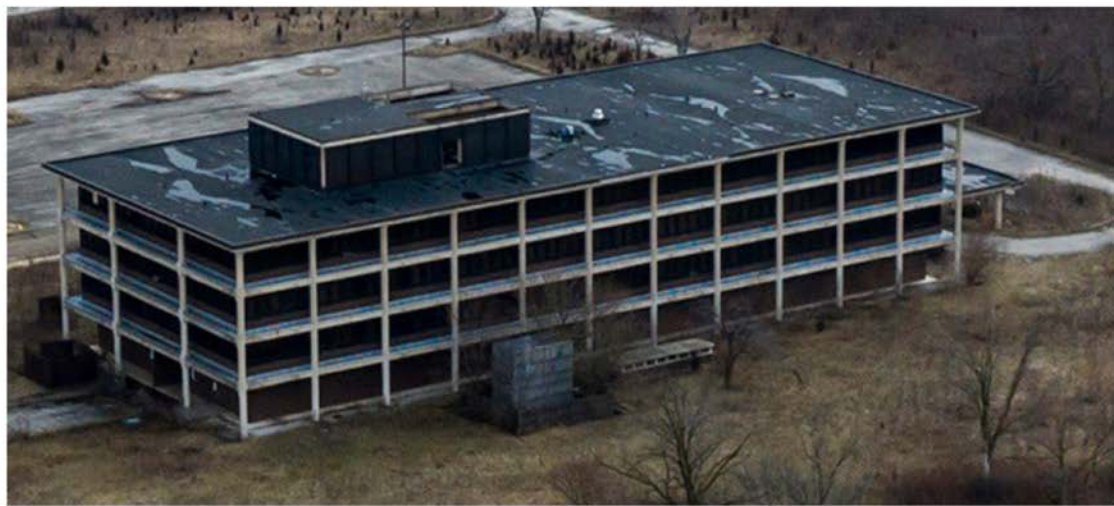
Maple Hall #26 CDB# BB026

Material	Quantity	Notes
TSI*	1,718 LF	Throughout on various pipe sizes (elbows and runs). This quantity is listed on the previous survey; very little was accessible and most appears to be fiberglass except for the joints.
Cementitious Insulation on Ducts	500 SF	None
Cementitious Material on Booster Pump	128 SF	None
Rope Insulation around Access Panel	3 LF	None
9" X 9" Floor Tile and Mastic	59,393 SF	None
1' X 1' Floor Tile and Mastic	4,474 SF	None
Fire Door - Wood	1	None
Fire Door - Metal	60	None
Vibration Damper Insulation	8 SF	None
Fire Damper Insulation	2 SF	None
Exhaust Backdraft Damper	18 each	None
Carpet and Mastic Door	NA	Could not identify/verify
Transite Duct under Door	NA	Could not identify/verify
Electrical Wiring	NQ	Not quantified
Electrical Panel Components	NQ	Not quantified
Elevator Doors/Equipment	1 Elevator Car	None
Transite Louvers	NA	Could not identify/verify

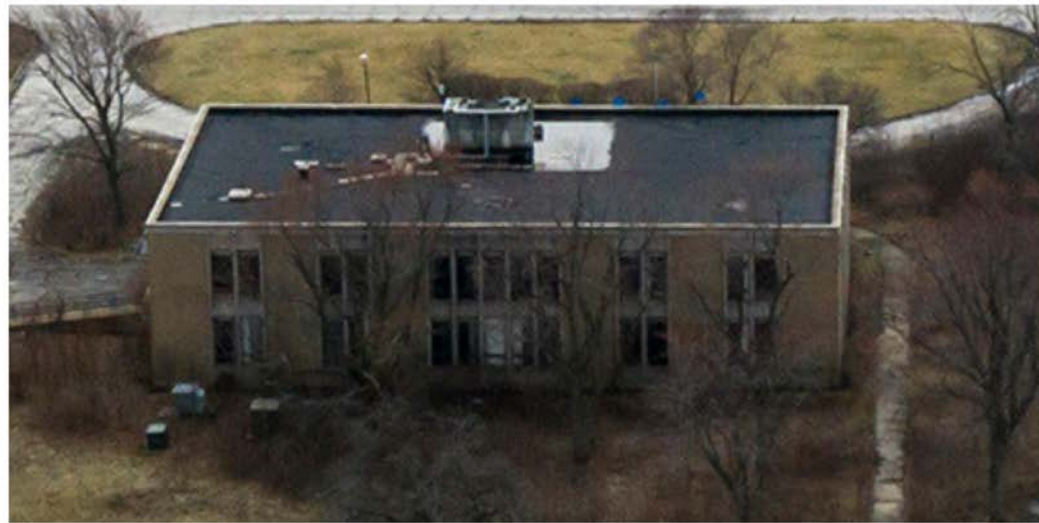
Administration Building #27 CDB# BB027

Material	Quantity	Notes
TSI*	400 LF	None
Tank Insulation	260 SF	None
9" X 9" Floor Tile and Mastic	15,158 SF	Within some carpeted areas, the 9" X 9" floor tile has been removed but the mastic remains.
1' X 1' Floor Tile and Mastic	750 SF	None
Fire Door - Metal	7	None
Transite Siding around Cooling Tower	300 SF	None
Insulation on Fire Dampers	50 each	None
Electrical Wiring	NQ	Not quantified
Electrical Panel Components	NQ	Not quantified
Liner Inside Cooling Tanks	NA	Could not identify/verify

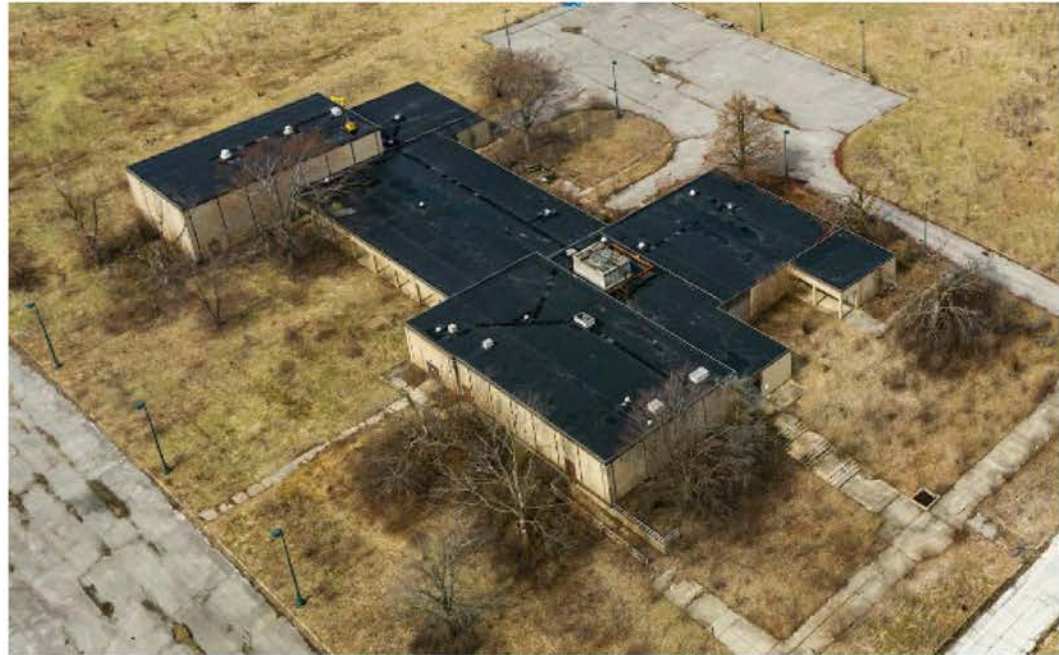
Mimosa Hall #29 CDB# BB029

Material	Quantity	Notes
TSI*	3,000 LF	Throughout various pipe sizes. Main level above the ceiling hot and cold water lines are wrapped, but due to limited access, could not verify how much of this material is fiberglass and how much is ACM
9" X 9" Floor Tile and Mastic	1,590 SF	None
1' X 1' Floor Tile and Mastic	2,704 SF	None
Fire Door - Wood	7	None
Fire Door - Metal	7	None
Mastic under Wood Floor	4,500 SF - Gym 792 SF - Auditorium Stage	None
Carpet Mastic over Vinyl Tile	2,679 SF	None
Fire Damper Insulation	32 SF	None
Exhaust Backdraft Damper Insulation	96 each	None
Canvas Vibration Damper	16 SF	None
Electrical Wiring	NQ	Not quantified
Electrical Panel Components	NQ	Not quantified
Transite on Cooling Tower	350 SF	None

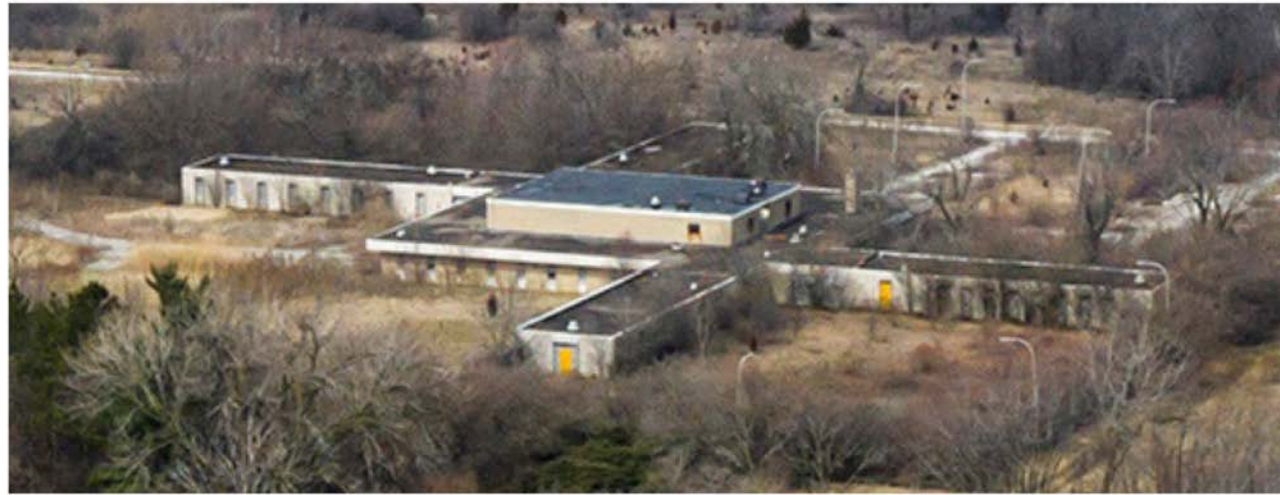
Cedar Hall #32 CDB# BB032

Material	Quantity	Notes
TSI*	888 LF	Mechanical room in basement is inaccessible due to flooding; therefore, the quantity estimate is based on 1994 Fox OM Plan
1' X 1' Floor Tile and Mastic	352 SF	None
9" X 9" Floor Tile and Mastic	2,560 SF	None
Sheet Goods with Mastic	18,738 SF	None
Fire Doors - Metal	8	None
Built-up Roofing	4,900 SF	None
Mastic under Wood Floor	3,750 SF	None
Fire Damper Insulation	4 SF	None
Electrical Wiring	NQ	Not quantified
Electrical Panel Components	NQ	Not quantified
Exhaust Backdraft Damper Insulation	8 each	None
Lead-Based Paint	25 SF	Orange door/door frame
